ENGINEERING EVALUATION OF DEPTH-SOUND
SPEED MEASURING SET AN/BQH-1 MANU-
FACTURED BY DYN-A-EMPIRE CORPORATION,
GARDEN CITY, NEW YORK. CONTRACT NOBSR-
75772

Navy Underwater Sound Laboratory
New London, Connecticut

10 March 1961

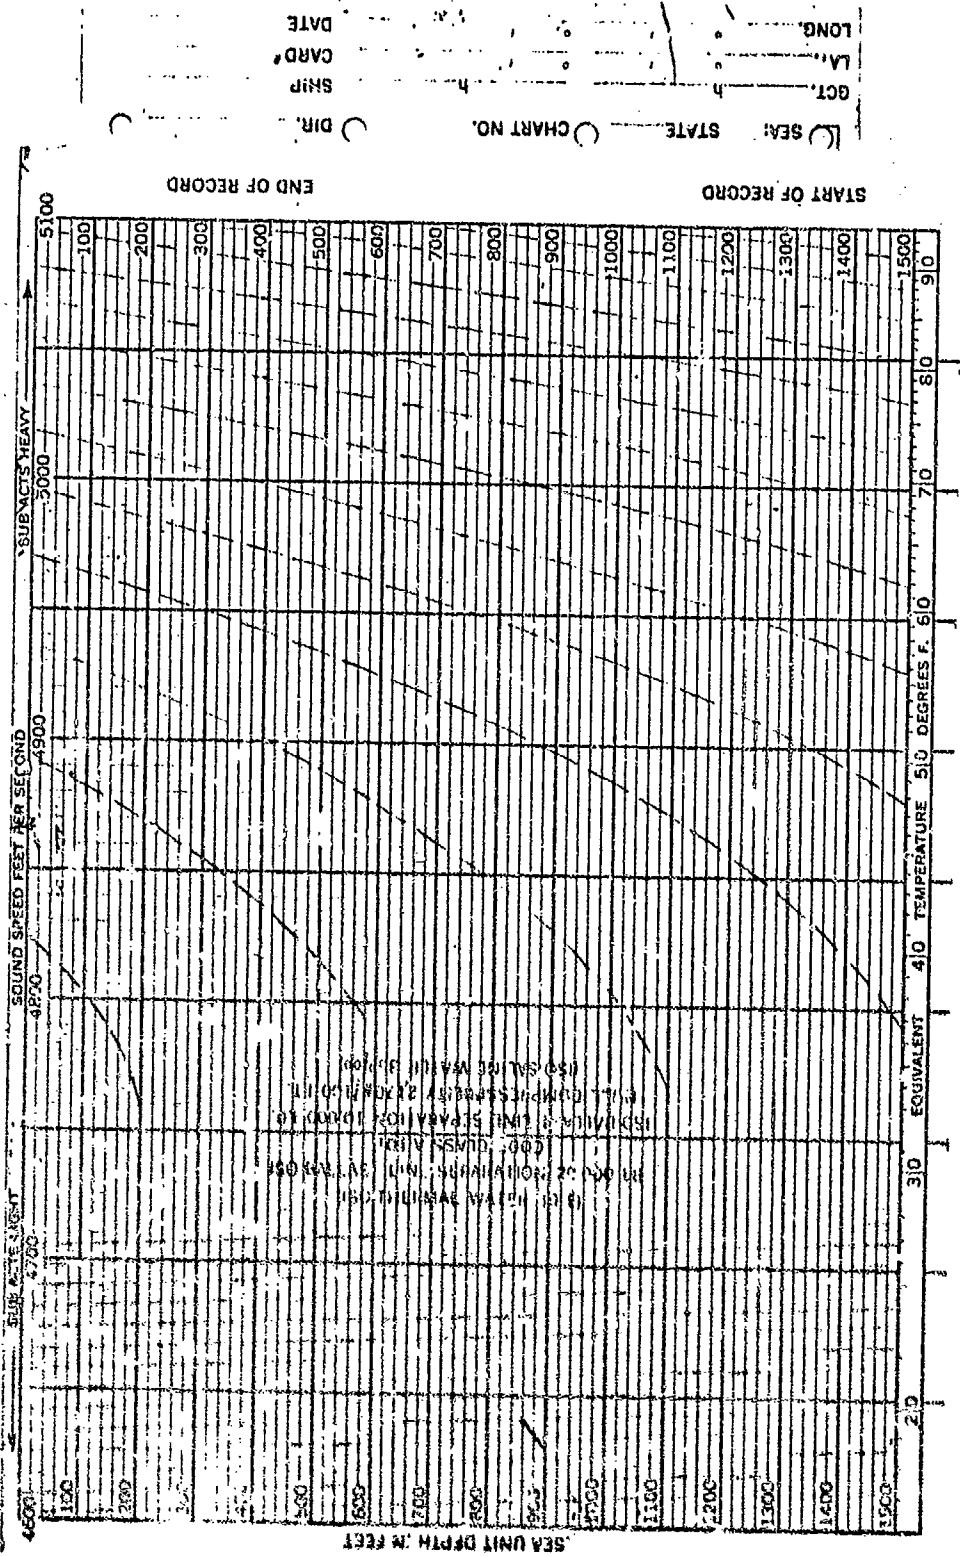
Fig. 5 - Chart paper used in AN/EOH-1 Depth-Sound Speed Measuring Set

The sound velocity is presented on pressure-sensitive graph paper as a function of the depth of the submarine (see Fig. 5). The sound velocity axis is calibrated in 10 ft/sec intervals from 4800 to 5100 ft/sec; the depth scale is calibrated in 20-foot intervals from 0 to 1600 feet. Also included on the charts are two sets of

The chart is required to have scale divisions of 10 ft/sec, and a slope change of 1 ft/sec in the sound velocity should be readable. By exercising caution in the reading of the chart, it is possible to read the sound velocity to the nearest 2 ft/sec, but reading to 1 ft/sec would not produce consistent results. The ability to read within 2 ft/sec is considered sufficient.

The chart is not provided with red illumination as required by the equipment specification. The charts are illuminated by clear bulbs, with amber-colored glass being used in the cover of the equipment. The intensity of the lamps is variable, and at maximum intensity the light was judged to be excessively bright. The contractor maintains that if red-tinted bulbs were to be used, it would not be possible to see the chart trace because of the large area that must be covered. Final approval is contingent upon the contractor's providing an illumination system suitable to the Bureau.

1. Modify sound head circuitry so that calibration reading is not temperature dependent.
2. Provide proper red illumination for the chart.
3. Mount electrolytic and tubular capacitors so that they will stay in place and not break leads.

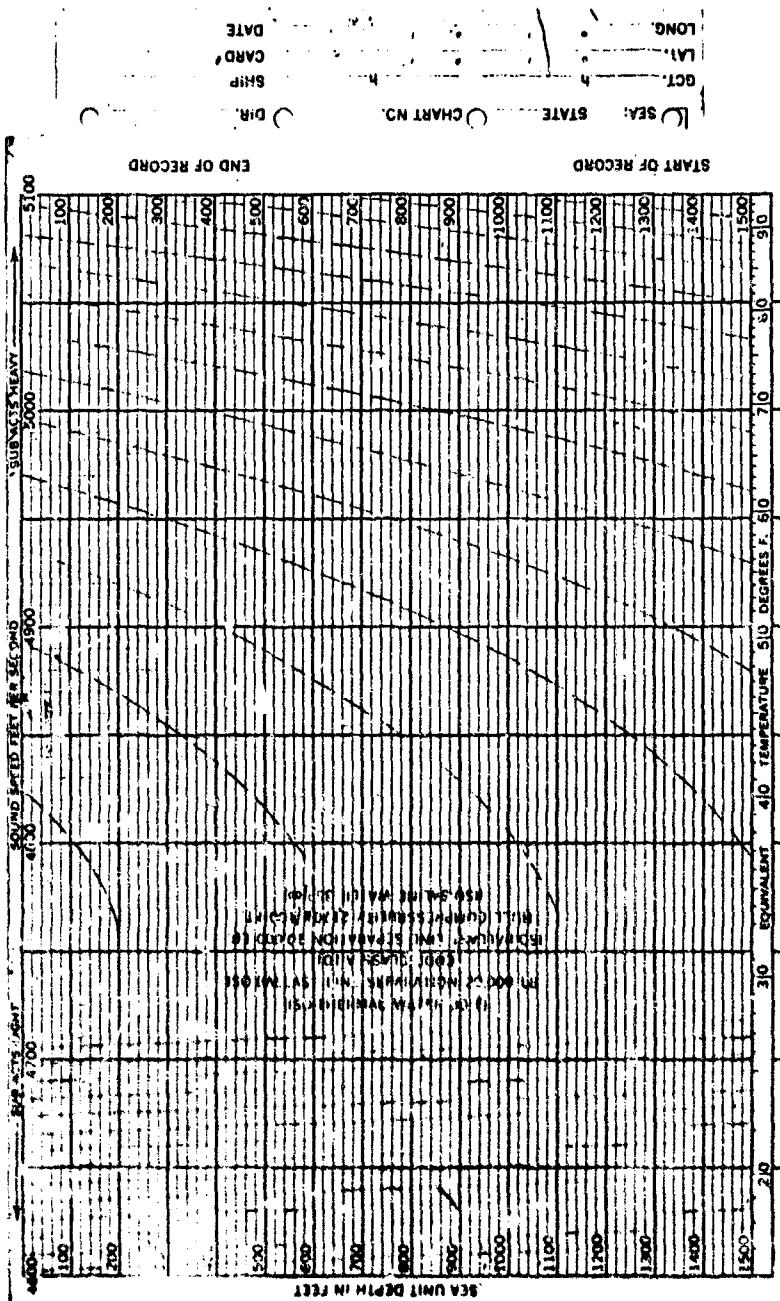
The sound head of the AN/BQH-1 was immersed in a temperature-controlled bath of distilled water, and the bath temperature and the reading of the stylus on the chart were recorded. Figure 6 shows the relationship between the sound velocity as recorded by the AN/BQH and the data obtained from the NBS report. The recorded sound velocity was within 10 ft/sec of the NBS values over the temperature range of 0° C. to 30° C. No tolerance for the sound velocity measurement was spelled out in the equipment specification, but this amount of error is considered to be acceptable.
